## **CASE STUDY** Liquid Nightclub

**Project:** Demolition of Liquid Nightclub  
**Client:** Ron Hull JNR Limited  
**Date:** October 2015

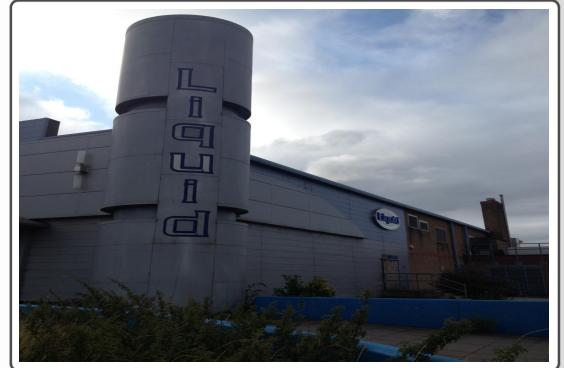
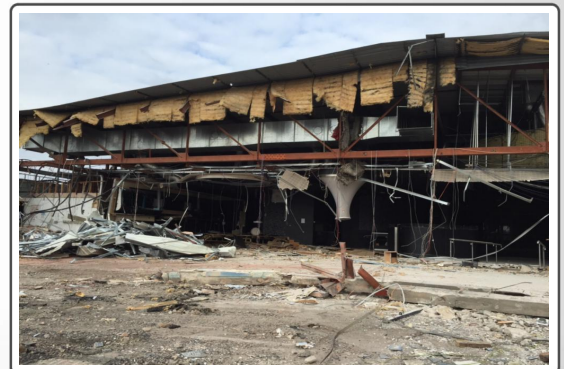
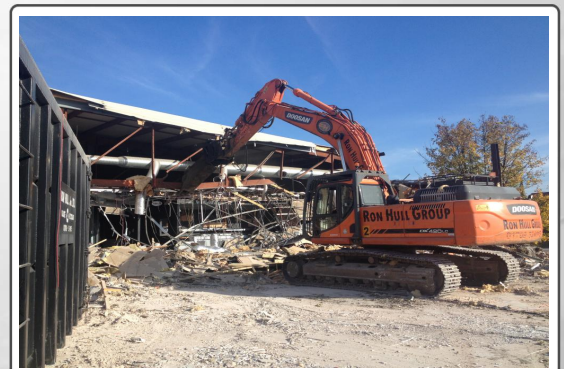
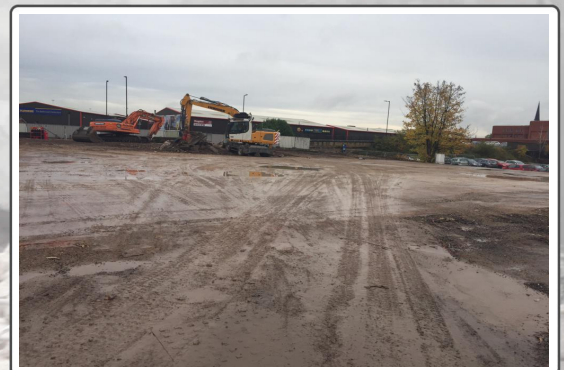
Using an excavator with grab attachment works commenced, removing infill brick/block between two column lines to allow the machine access into the building. Once completed the machine operative removed non-structural walls, ducting and false ceilings in the first bay, segregating and loading arisings. This procedure was repeated to clear the next bay, brick/block arisings were used to create a ramp down into the building. A column was then removed to enable a waste skip to be sited in the building to minimise airborne debris. The clearance of the remaining bays, working progressively westwards, then took place and any arisings were loaded into skips within the building.

Using excavator shear and working internally, the machine sheared and removed cladding, purlins and diagonal bracing from the roof. This allowed the excavator, sited externally, to demolish block/brickwork from south gable and east side wall.

Next, working from the plant room roof the RHD specialist team, flame cut through various top tie beams. This was repeated to remove tie beams on the east elevation. From ground level, a hinge support column was cut at the east side and working from the plant room roof, flame cutting was used again through bolt on stub column flange. RHD's 45t excavator/shear was used at the east elevation to pull re weakened column westwards causing the support beam to drop into the building.
