Demolition of Rossington Concrete Water Tower

Location:	Rossington, Doncaster
Scope:	Demolition of concrete water tower and brick-built pump house and remove all arisings
Disciplines:	Demolition, crushing, groundworks and waste disposal
Client:	JN Bentley Ltd
Programme:	2 weeks
Value:	£100,000

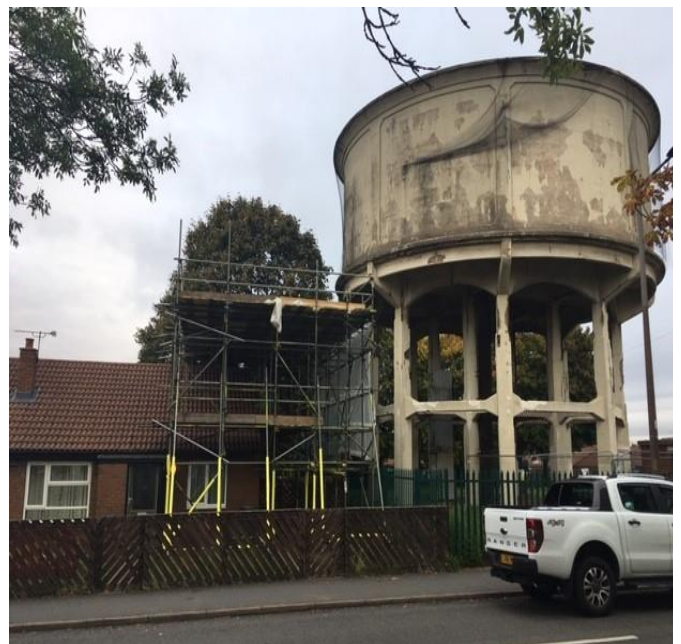
The concrete water tower consisted of 10 no. concrete reinforced columns supporting the concrete water tower with rebar, there was evidence the structure had degraded over time.

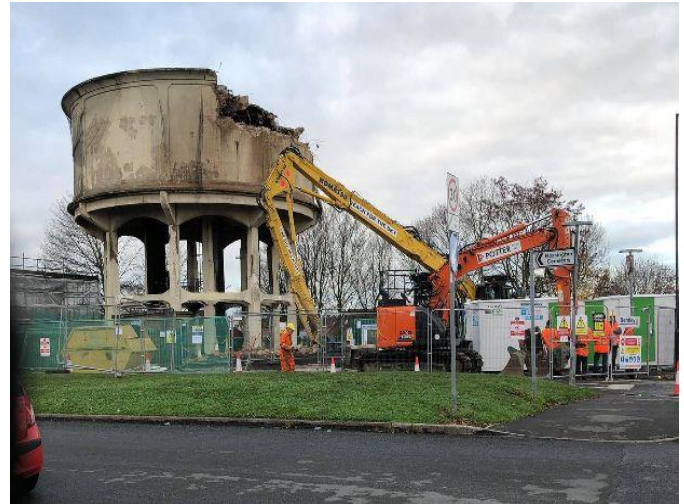
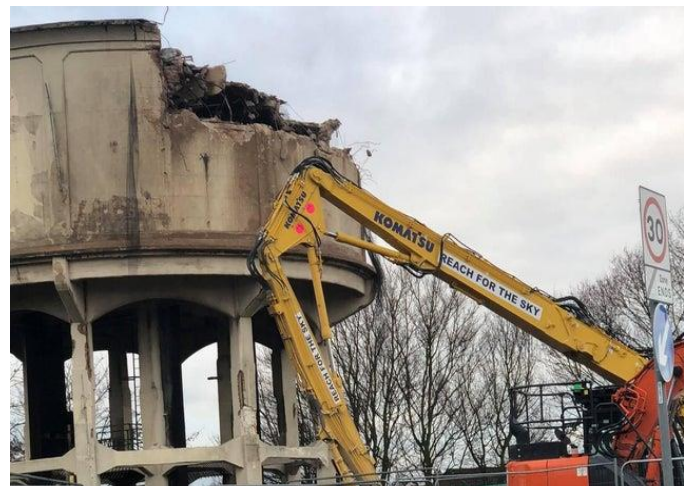
Once all columns had been demolished down to the intermediate supports, the high reach machine was removed from site and replaced with a 21 tonne

excavator. The Excavator detached and processed the columns down to ground level.

The high reach excavator with cracker jaw attachment penetrated into sections of the concrete water tower progressively working towards 50% half way down the tower. Throughout these works the concrete column supports remained intact for stability.

This element of the works was carried out in a top down method working around the concrete tower taking down sections by a meter at a time this maintained structural stability of the tower. The four inner concrete columns were reduced down to biscuit level once accessible. The internal steel overflow pipes were pulled up and removed out of the drum when accessible.
